# GUIDE FOR TROUBLESHOOTING

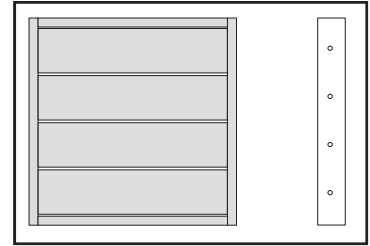
## (A)

- If light lines are present across the full length of the blade, check that closing torque being applied is neither too little nor too much.
- Under-rotation will not let blade gaskets compress, whereas over-rotation can cause blades to re-separate.

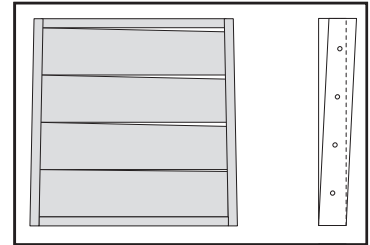
## (B)

- If light lines are observed only along half of the blade length, square up the position of the top frame member, relative to the bottom frame, by pivoting the top frame member either in or out.
- A small movement in one of these two directions could seal light lines, by eliminating frame distortion caused by torque being applied to an unsecured damper.
