# Case Study

## SiteBilt® AT 920 BROAD STREET

### SOLUTIONS FOR TIGHT SPACES

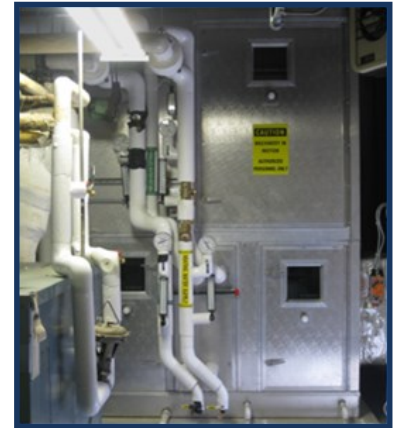
Over time, standard air handling units will succumb to environmental factors such as rusting and seal failure. When a unit's components deteriorate, its ability to perform to acceptable standards does as well. The AHU located in the Hartford Juvenile Detention Facility at 920 Broad Street in Hartford, CT was one such unit that was facing these issues. Time-induced wear and tear on the system had become so problematic that the only possible remedy was to replace the unit in its entirety. This endeavor was complicated by the fact that the old air handling unit was located in a small, difficult-to-access space. Attempting to install a fully assembled unit would require demolishing a wall or drastically altering the area. A resolution was needed to avoid any costly or time-consuming construction projects.

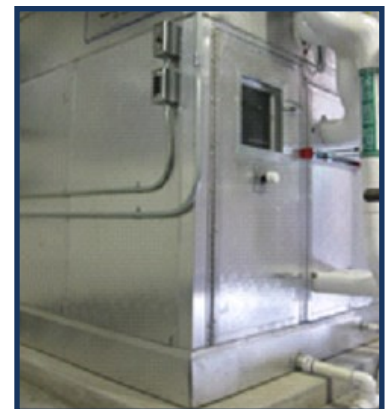
The AHU was custom designed to fit the location of the old unit after several site visits, measurements and much double-checking from Flow Tech. Environmental effects were kept in mind so features such as corrosion-resistant, all-aluminum construction were used to ensure that the unit's functionality was long lasting. Finally, a field advisor was supplied by Air Enterprises to oversee the construction project and ensure its success. Months later, feedback was highly positive as the new unit was moving a greater volume of air more efficiently than the old system.
